RESEARCH AND INVESTIGATION INTO THE PERFORMANCE OF RESIDENTIAL **BOUNDARY FENCING IN BUSHFIRES**

A recent testing project involving the Co-operative Research Centre for Bushfire (Bushfire CRC) and the CSIRO has revealed that different types of fencing can play an important part in defending homes against the threat of bushfire.

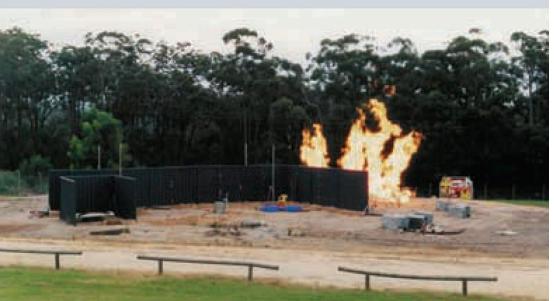
NSW RURAL FIRE SERVICE EXPERIMENTAL TESTING SITE AT MOGO

The research project was conducted in the NSW Rural Fire Service Experimental Testing Site at Mogo on the south coast of NSW, at what is believed to be the only bushfire simulator of this type in the world.
